**Flood Control Project Maintenance
Levee Inspections**

Maintenance Issue Types Only, Levee Inspection Report By Mile - Spring 2015

Levee District No. 0009 (Sutter County)

Waterway	Bank	Unit Miles	Inspection Start/End	Inspector
Unit No. 01 Sutter County, Feather River	Right	6.25	05/20/2015 05/20/2015	Michael Pitta

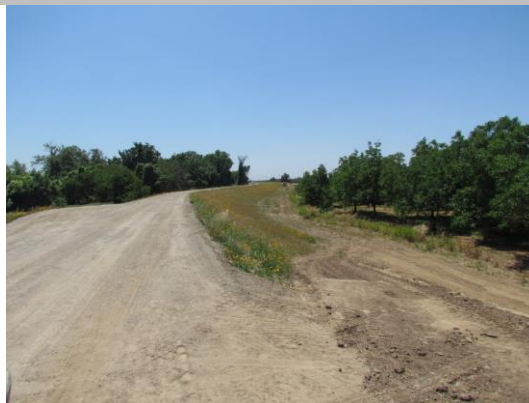
Photo 1 of 1 : SP_2015_LD0009_202_26_20150521_00020.jpg

LM Start	0.01	Rating **	M	Issue No.	26
LM End	6.25	Issue Type +	Ma	Location *	LS
Category	Earthen Levee			GPS Latitude/Longitude	
				Start	End
Item	Vegetation			39.170345 °	39.254369 °
				-121.622532 °	-121.636530 °
DWR ID	DWR_LD0009_01_s_2015_26				
Action/Comments					
Control annual grass and weeds on the levee slopes and easements.

View of the vegetation on the landside of the levee facing upstream.

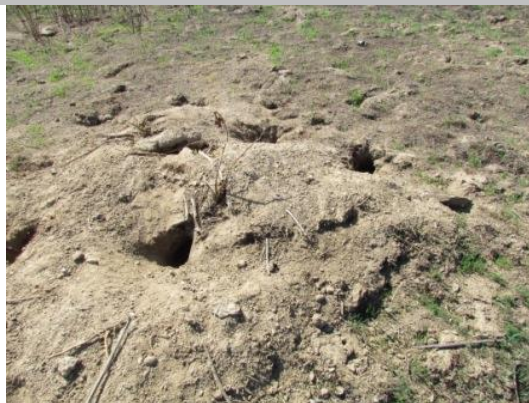
Photo 1 of 1 : SP_2015_LD0009_202_22_20150401_00007.jpg

LM Start	3.10	Rating **	A/W	Issue No.	22
LM End	3.30	Issue Type +	Ma	Location *	WS
Category	Earthen Levee			GPS Latitude/Longitude	
				Start	End
Item	Animal Control				°
					°
DWR ID	DWR_LD0009_01_f_2013_22				
Action/Comments					
No rodents visible, but rodent burrows visible; need to backfill and compact or grout burrows. Inspector Comments: Large burrows on waterward levee slope. Will be repaired when the slurry wall is installed summer 2014.

Photo taken looking south from the toe of the levee at rodent holes on the waterward slope.

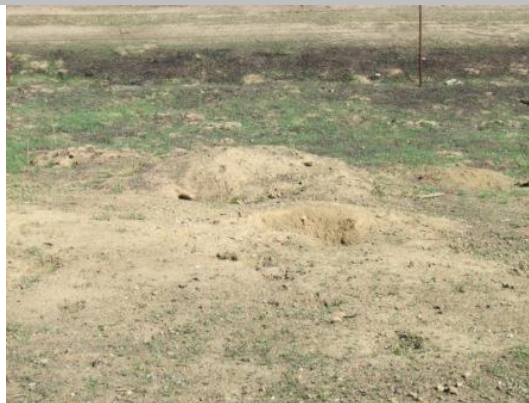
Photo 1 of 1 : SP_2015_LD0009_202_10_20150401_00002.jpg

LM Start	4.69	Rating **	A/W	Issue No.	10
LM End	4.69	Issue Type +	Ma	Location *	WS
Category	Earthen Levee			GPS Latitude/Longitude	
				Start	End
Item	Animal Control			39.234343 °	39.234343 °
				-121.632200 °	-121.632200 °
DWR ID	DWR_LD0009_01_f_2013_10				
Action/Comments					
No rodents visible, but rodent burrows visible; need to backfill and compact or grout burrows.

Photo taken from the levee crown looking east down the waterward slope at rodent holes.

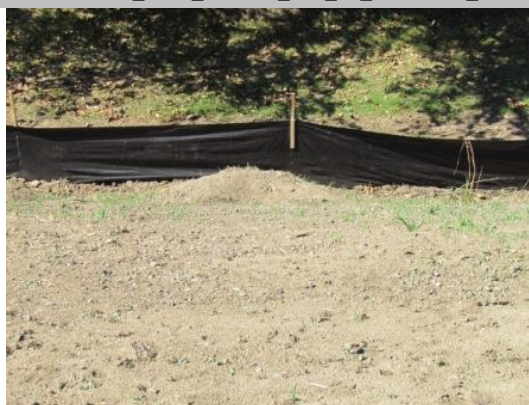
Photo 1 of 1 : SP_2015_LD0009_202_25_20150401_00010.jpg

LM Start	6.14	Rating **	U	Issue No.	25
LM End	6.14	Issue Type +	Ma	Location *	LS
Category	Earthen Levee			GPS Latitude/Longitude	
				Start	End
Item	Animal Control			39.254369 °	39.254369 °
				-121.636531 °	-121.636531 °
DWR ID	DWR_LD0009_01_f_2013_25				
Action/Comments					
No rodents visible, but rodent burrows visible; need to backfill and compact or grout burrows.

Photo taken from levee crown looking west down landward slope at rodent holes.
